LAKE GALA NATIONAL PARK
WASTE TYPES AND QUANTITIES
CURRENT STATE ANALYSIS

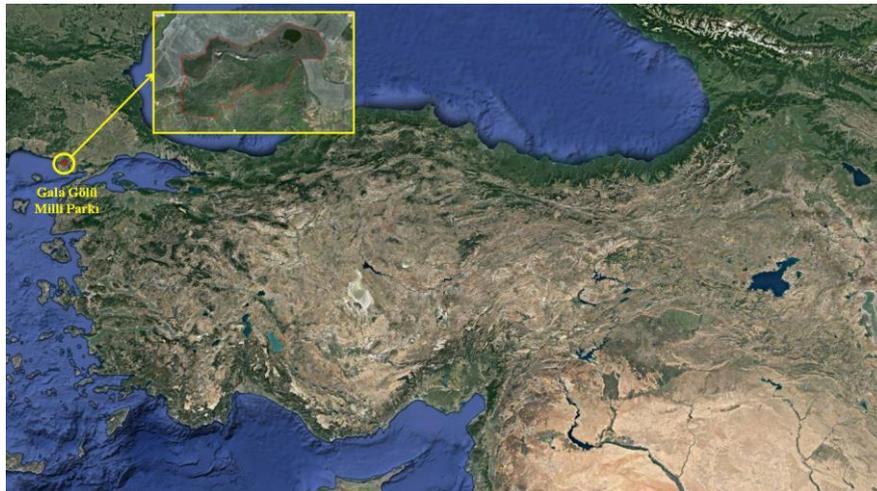
Figure 1. Location of Lake Gala National Park

Lake Gala National Park is located in the middle of Ipsala and Enez Districts, in the area where the Meriç River flows into the Aegean Sea, also known as the Meriç Delta between 40° 46' 11.37" North - 26° 11' 14.87" East coordinates (Tokatlı & Gürbüz, 2014) (Figure 1). Lake Gala was formed as a result of the Meriç River changing its bed during heavy rainy periods, overflowing up to the foothills of Hisarlı and Çandır Mountains and blockage of the areas in the Meriç River Delta by the alluvium. The Lake consists of 2 parts: Grand Gala Lake (Çeltik Lake) and Small Gala Lake. These 2 lakes and Lake Pamuklu can form a single lake by being flooded during overflows in the basin (SHW, 2003). The area of Lake Gala is 556 ha and Lake Pamuklu is 188 ha (at 0 m elevation). The total lake area is 744 ha (Lake Gala Water Resources Management Plan, 2019). The surface area of Lake Gala varies depending on meteorological conditions and the release of the water taken from the lake for paddy irrigation works and left in the fields at the end of the harvest period. (Lake Gala Flora Fauna Final Report, 2016).

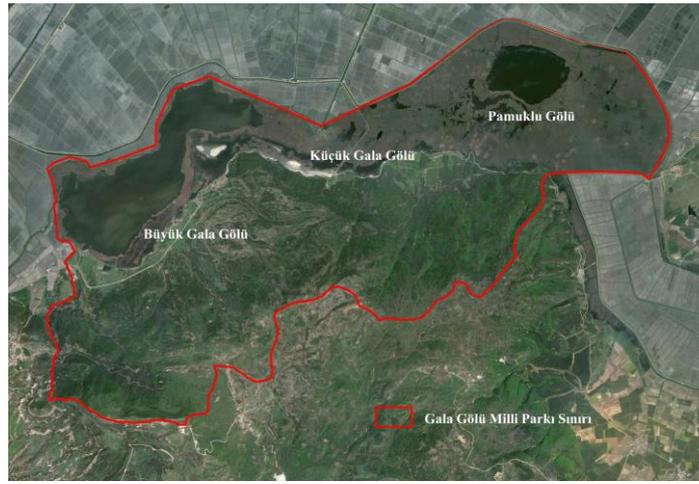
Figure 2. Borders of Lake Gala Lake National Park

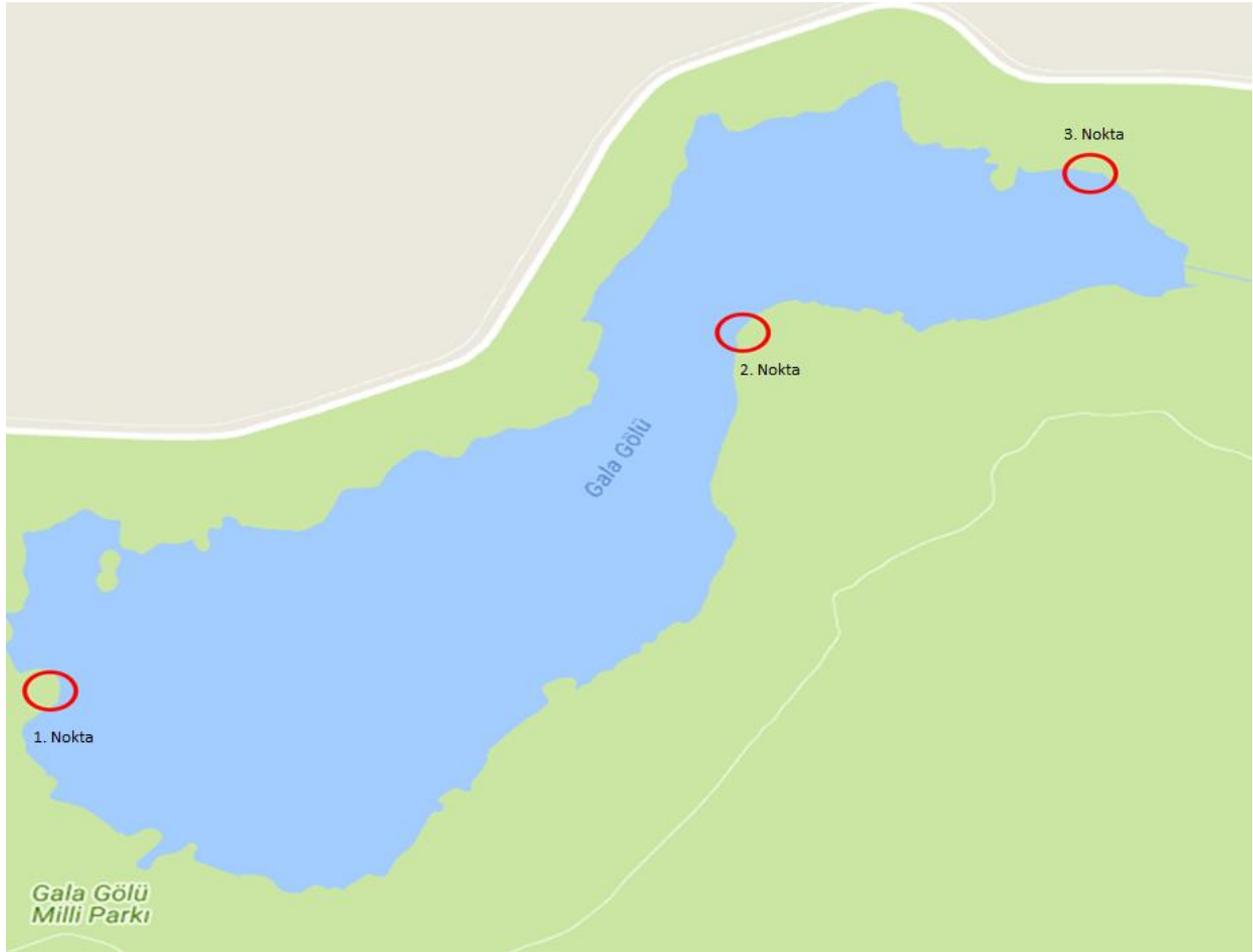
Figure 5. Sampling areas for Lake Gala water quality analysis (Gürbüz et al., 2018)

Within the scope of the IPA Transboundary Cooperation in Lake Gala, a study was conducted with the aim of evaluating the water quality under the project activities for the protection and restoration of natural heritage in Burgaz and Enez. Under the research study, physical, chemical and bacteriological analyzes were carried out by taking water samples from 3 sample areas between July 2017 and September 2018.

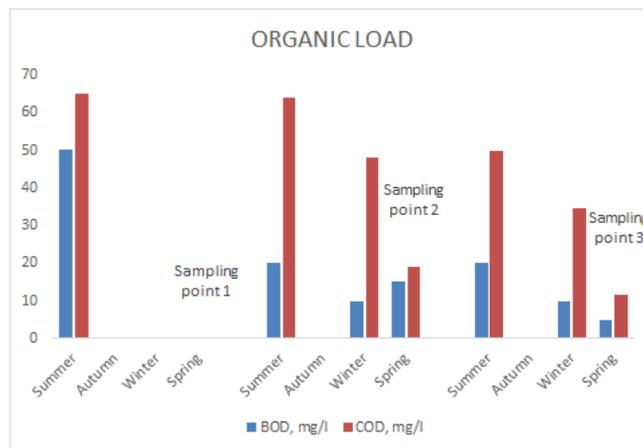
Figure 6. Seasonal display of BOD and COD parameters

- The oxidation parameters were not of a size to cause problems.
- Among the nutrients, only NH-N proved to be a problem.
- Faecal coliform pollution was detected in the lake water. Since the sampling was made from the lake shore, the intensive human and animal activities caused the values to increase in certain months.

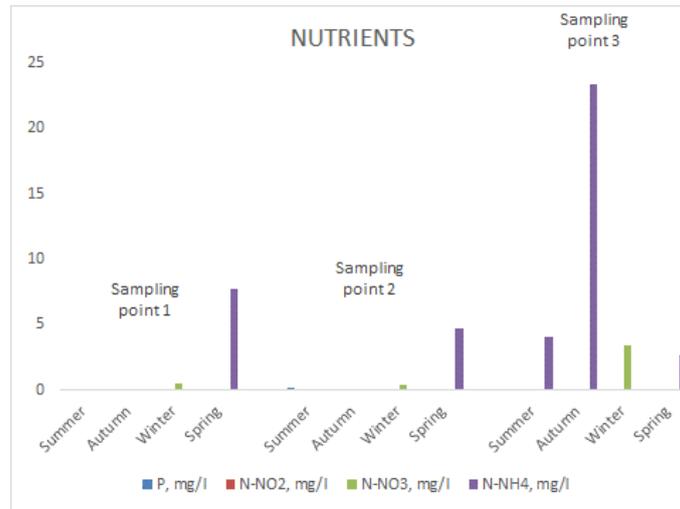
Figure 7. Seasonal representation of P, HN₄-N, NO₃-N and NO₂-N parameters

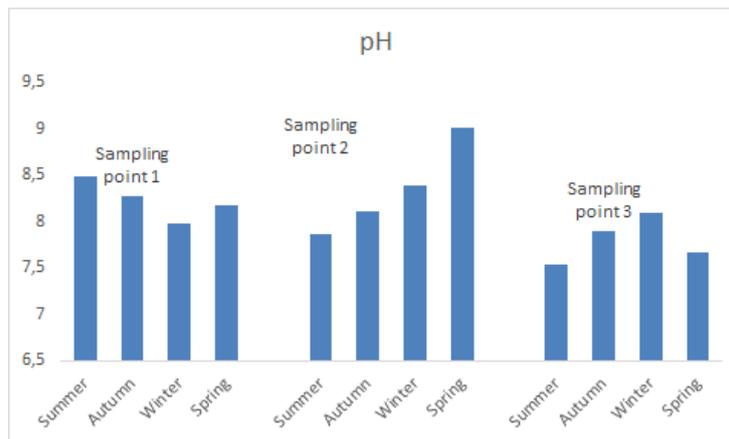
Figure 8 Seasonal representation of pH values

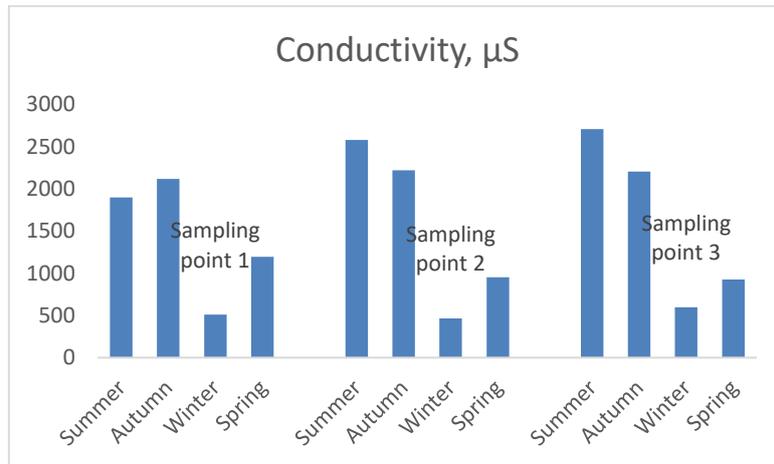
Figure 9. Seasonal representation of electrical conductivity values

- The results obtained in all three points were similar to each other.
- Salinity values varied between 0.185 and 2.708, and an increase in salinity was observed during summer. **In dry years, the salt ratio of the lake water increases as a result of the effect of the sea and water intake for paddy cultivation and this causes problems.**

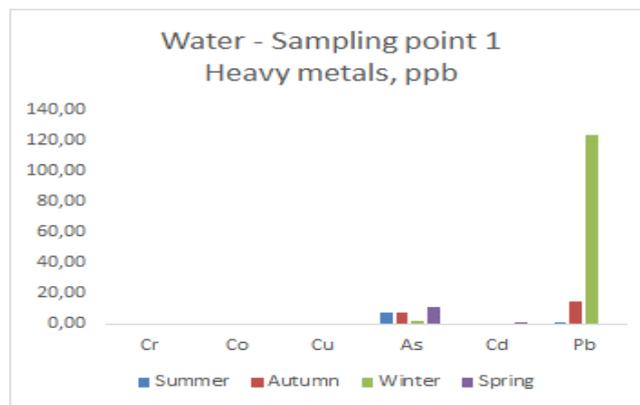
Figure 10. Seasonal representation of heavy metal values of water samples taken from the first sampling point

- Mn, Fe and Pb contamination was detected in some months.
- No Zn, Cu, Cr, Co, Ni and Cd contamination was found.
- Lake Gala is exposed to a significant amount of organic and inorganic pollution caused by the intensive agricultural activities carried out around the lake, some of the tail water returning from paddy fields in İpsala and Keşan Districts and mixing of the Ergene River water with the lake at a fair amount.

- It is estimated that the presence of excess lead (Pb) in the lake water in some months may be caused by the use of agricultural machinery during paddy cultivation periods and the traffic on the local roads.

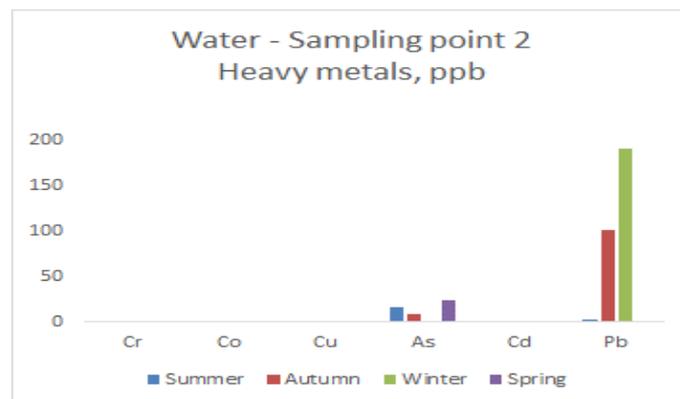
Figure 11. Seasonal representation of heavy metal values of water samples taken from the second sampling point

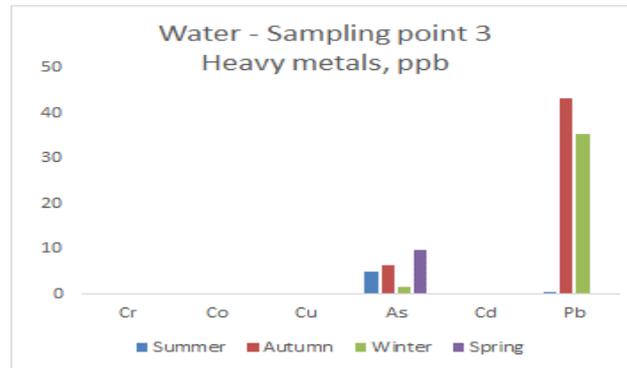
Figure 12. Seasonal representation of heavy metal values of water samples taken from the third sampling point

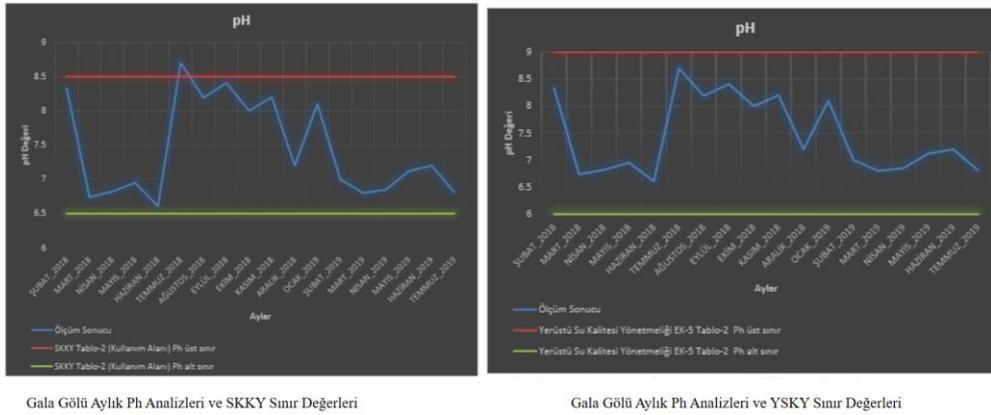
Figure 13. Lake Gala pH analysis -February 2018 to July 2019

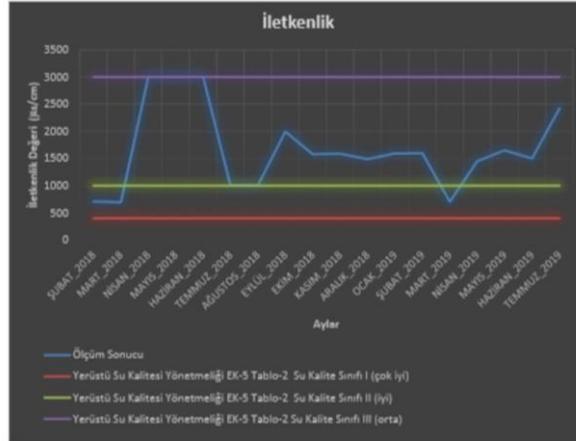
Gala Gölü Aylık İletkenlik Analizleri ve YSKY Sınır Değerleri

Figure 14. Lake Gala conductivity analysis- February 2018 to July 2019

- When the electrical conductivity (EC) values are examined, it is observed that the values are at maximum levels in April, May and June 2018. Due to the elevation difference caused by the fall of the lake level, the lake remains under the influence of sea water and the salt concentration and electrical conductivity of the lake water increase.

- The electrical conductivity (EC) values are predominantly between the water quality class II (good) and water quality class III (medium) specified in the Annex-5 Table-2 of the Regulation on Surface Water Quality. Due to the elevation difference caused by the fall of the lake level, the lake remains under the influence of sea water and the salt concentration and electrical conductivity of the lake water increase. Fish kills are observed due to high salt concentration

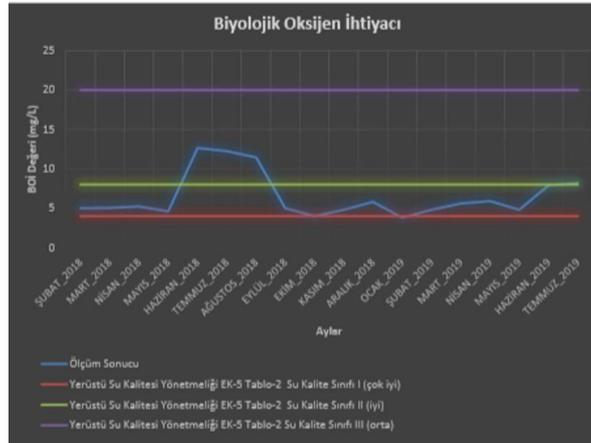
Gala Gölü Aylık BOİ Analizleri ve YSKY Sınır Değerleri

Figure 15. Lake Gala BOD analysis- February 2018 to July 2019

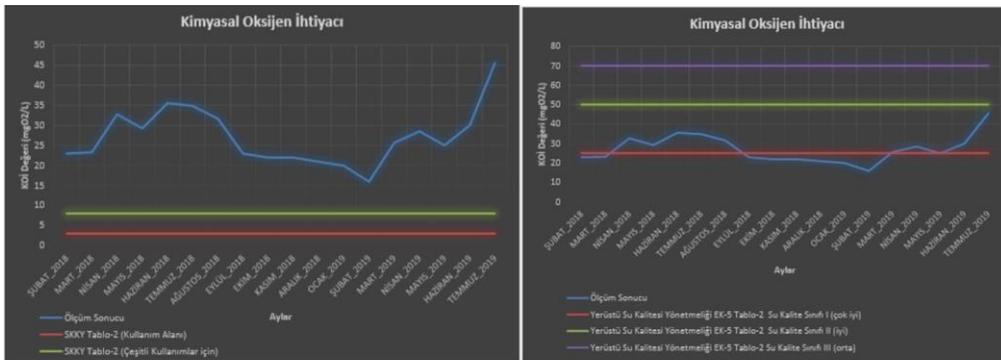
Gala Gölü Aylık KOİ Analizleri ve SKKY Sınır Değerleri

Gala Gölü Aylık KOİ Analizleri ve YSKY Sınır Değerleri

Figure 16. Lake Gala COD analysis- February 2018 to July 2019

- COD value is an important parameter indicating organic pollution in waters. Due to the increase in microbial activity in the spring and summer months, the rate of degradation of organic substances increases, thus, the COD value also increases. The lake is determined in 2nd class water quality according to Inland Water Resources Quality Criteria in terms of COD, which is one of the most significant pollution parameters. In terms of BOD values, Gala Lake is determined to have 3rd class water quality.
- Nitrogen and phosphorus forms are evaluated because phytoplankton play a limiting role in primary production. This situation occurs due to the decrease in the upper layer of the water, nitrogen and phosphorus and the increase in phytoplankton in the summer period.

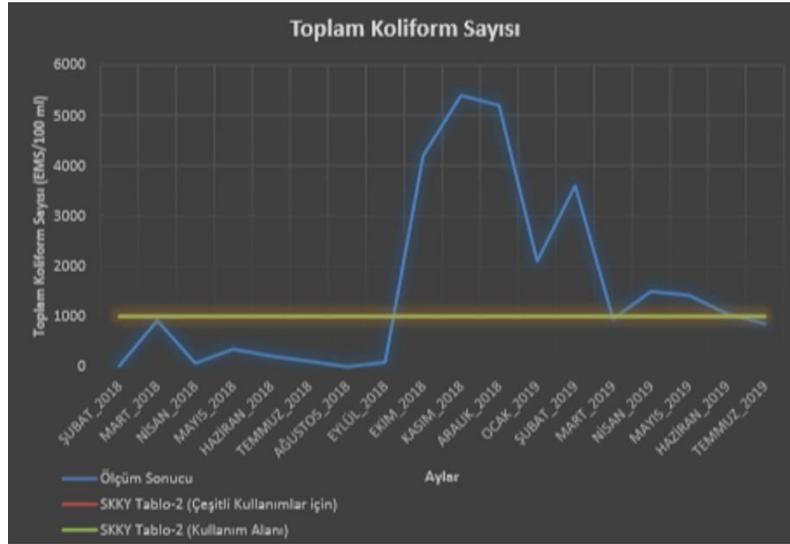
Gala Gölü Aylık Toplam Koliform Sayısı Analizleri ve SKKY Sınır Değerleri

Figure 17. Lake Gala coliform count analysis- February 2018 to July 2019

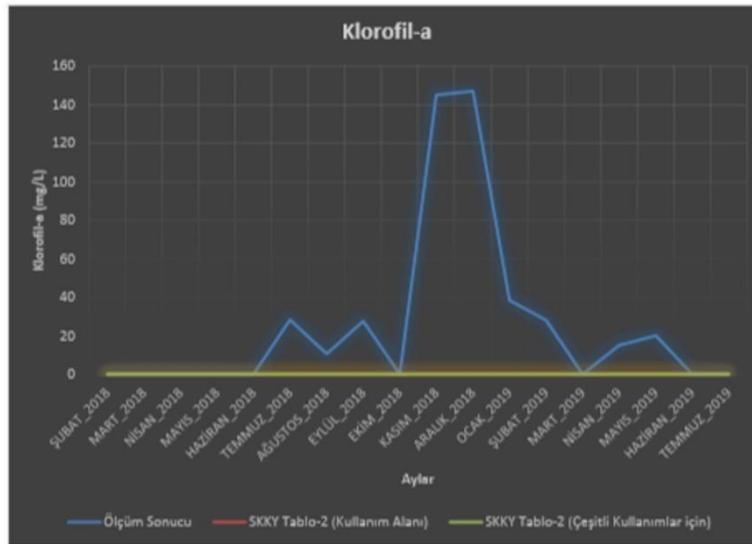
Gala Gölü Aylık Klorofil-a Analizleri ve SKKY Sınır Değerleri

Figure 18. Lake Gala Chlorophyll-A analysis- February 2018 to July 2019

- It is observed that TN and TP reached the highest levels in November, 2018 and Chl-a values reached their maximum levels in the period of November-December, 2018.

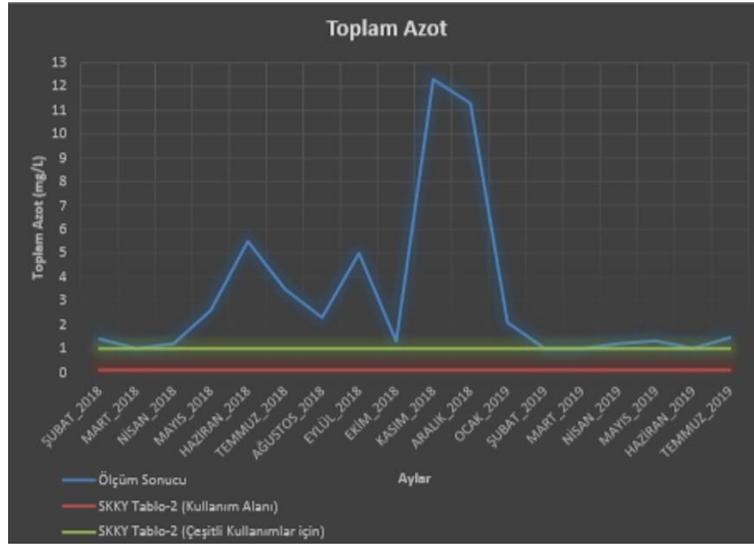
Gala Gölü Aylık Toplam Azot Analizleri ve SKKY Sınır Değerleri

Figure 19. Lake Gala Nitrogen analysis- February 2018 to July 2019

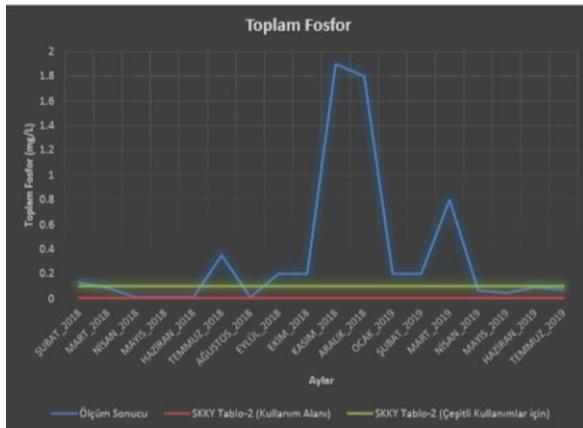
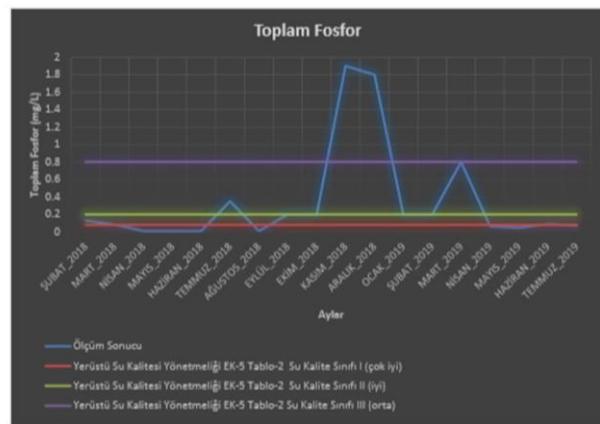
Gala Gölü Aylık Toplam Fosfor Analizleri ve SKKY Sınır Değerleri

Gala Gölü Aylık Toplam Fosfor Analizleri ve YSKY Sınır Değerleri

Figure 20. Lake Gala Phosphorus analysis- February 2018 to July 2019
